**Maritime Alliance Group, Inc.**

Vessel: JOHN H. GLENN JR.

## **REPORT OF SURVEY**

Vessel: Fireboat FB-2

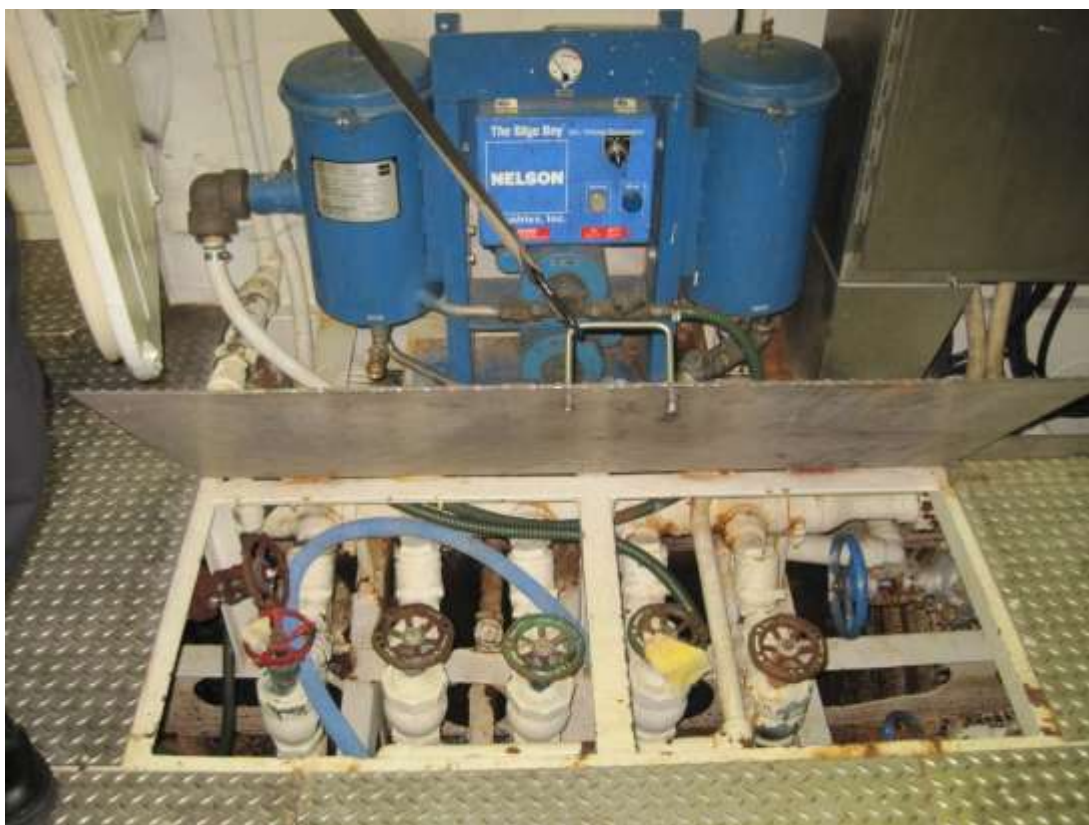
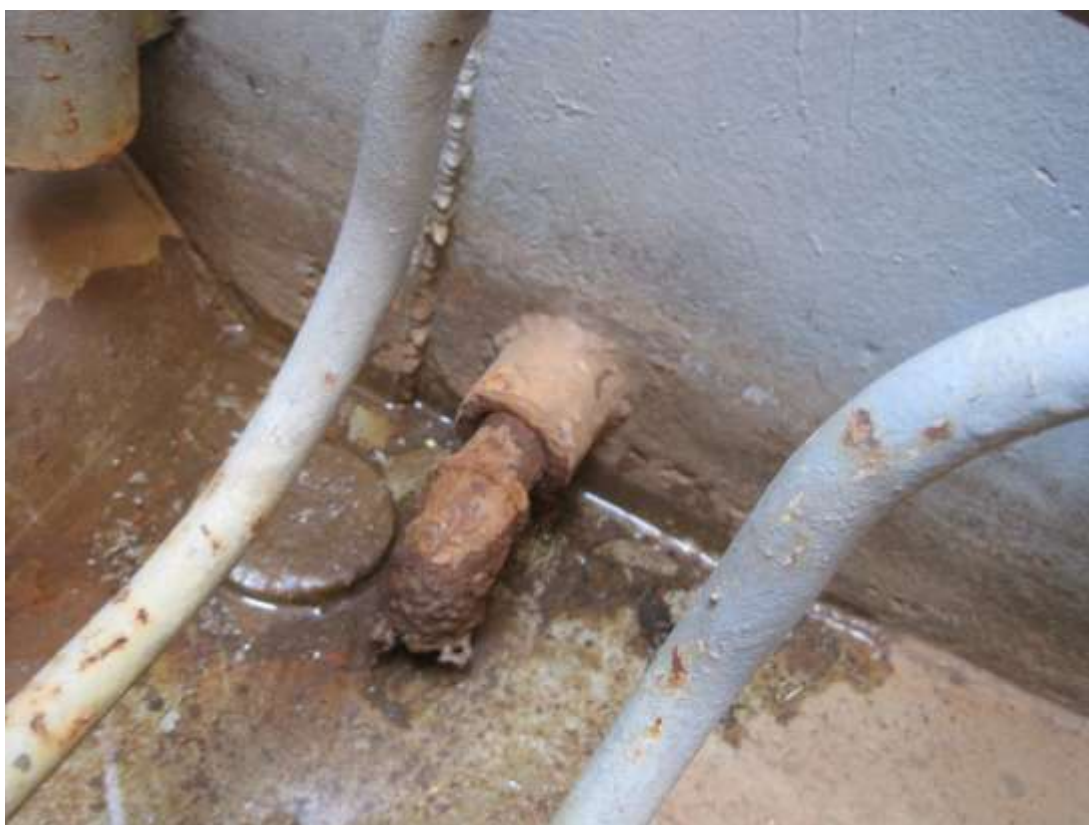
Photo Nos. 7 and 8: Bilge manifold and typical bilge suction.

CONDITION	RECOMMENDATION
Hull plating (original thickness 7/32" to 5/16') last audio-gauged in 2003; vessel built in 1962.	Audio-gauge entire hull at upcoming drydock availability. Crop and renew any plating that has lost more than 25% of original thickness.
Internal examination reveals considerable pitting to hull plating in lazarette compartment, and a cement patch approximately 20"x20"x5" to bottom plating in starboard forward corner of lazarette.	Crop and renew pitted hull plating in lazarette area to good metal. Examine and evaluate sacrificial anodes and renew as needed while in drydock.
Forepeak tank not accessible for internal examination.	Open, ventilate, and make forepeak tank available for internal examination in drydock.
Bilge pumping arrangements (central 120 GPM pump with manifold, valves, and suctions in each compartment) does not provide for automatic operation or alarm of flooding conditions. Pump cannot presently take suction reliably from all compartments, and requires priming.	Add separate bilge pumps in each compartment, with automatic float switch operation and audible alarms. Overhaul current pump/piping as necessary to provide high-capacity flooding control as a backup to smaller individual automatic pumps.

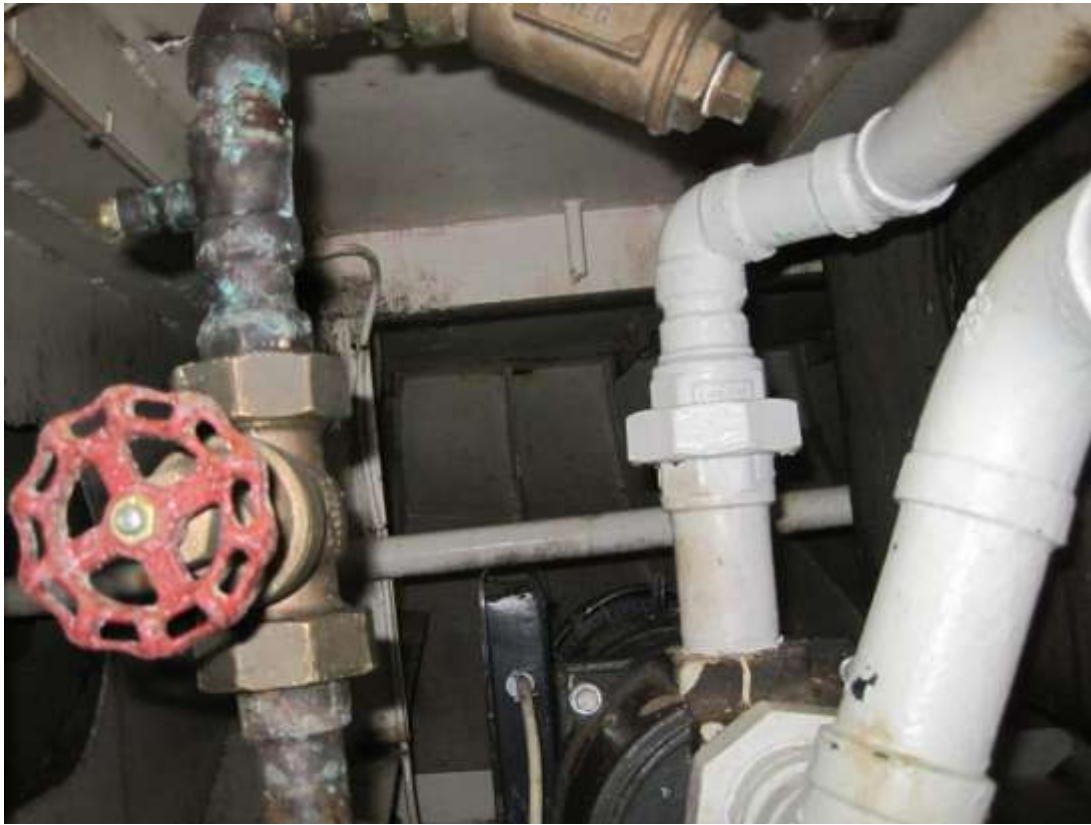
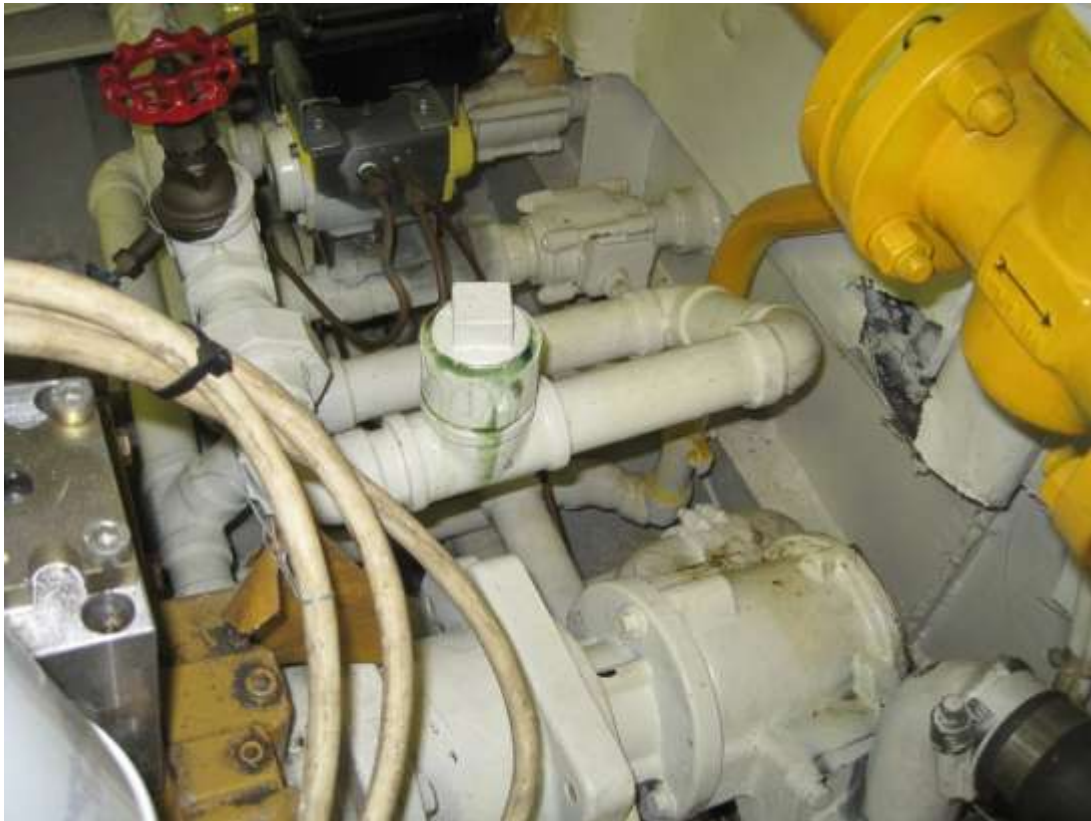
Photo Nos. 9 and 10: General views of piping in bilge areas; note green corrosion/leakage at fitting of foam piping.

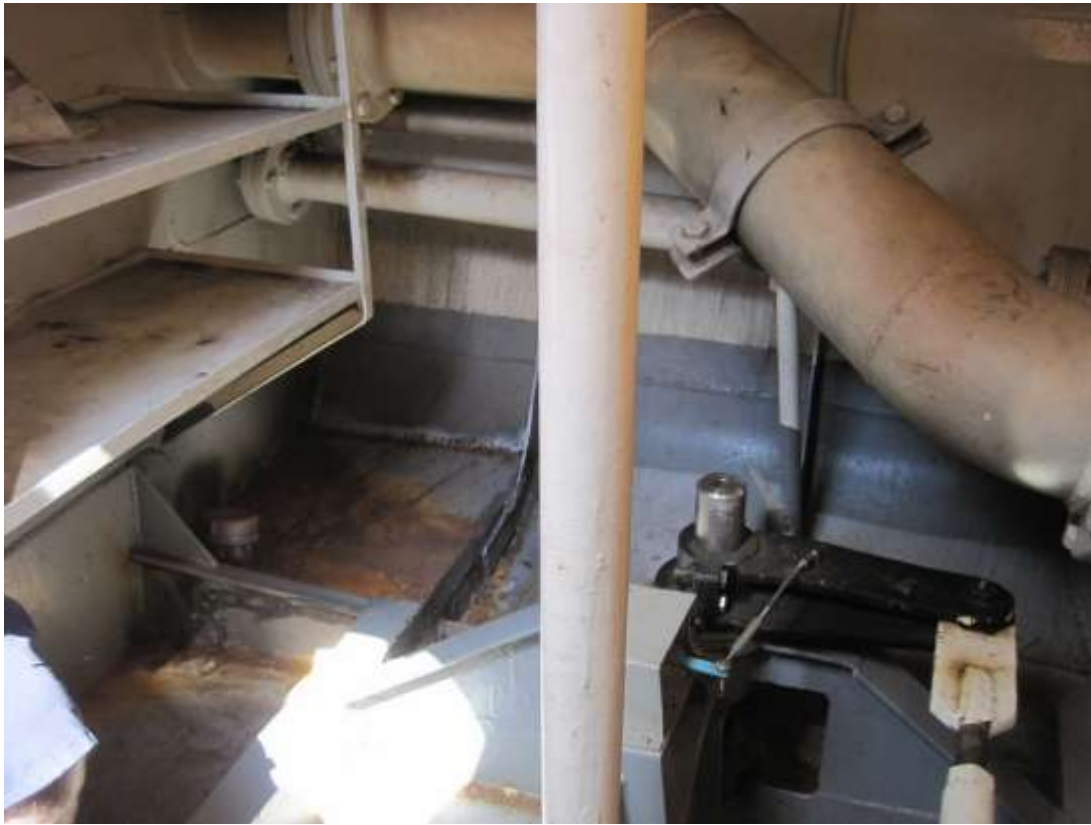
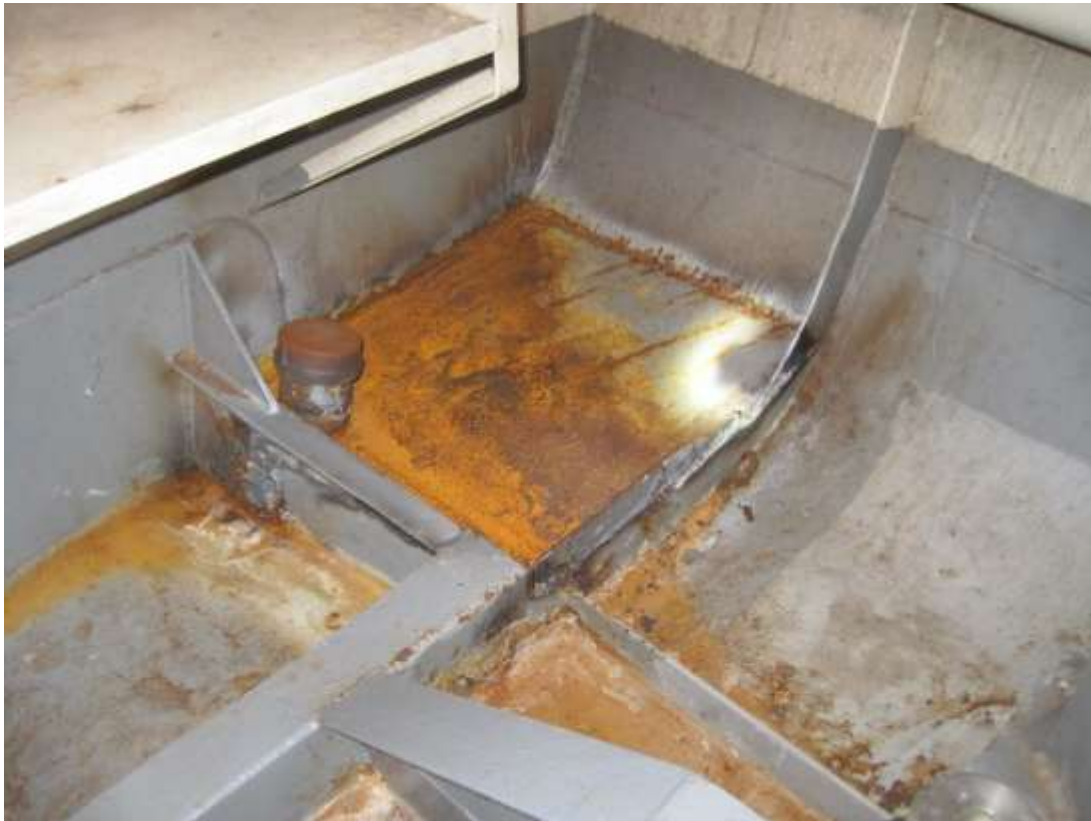
Photo Nos. 13 and 14: Cement patch in forward starboard corner of lazarette.

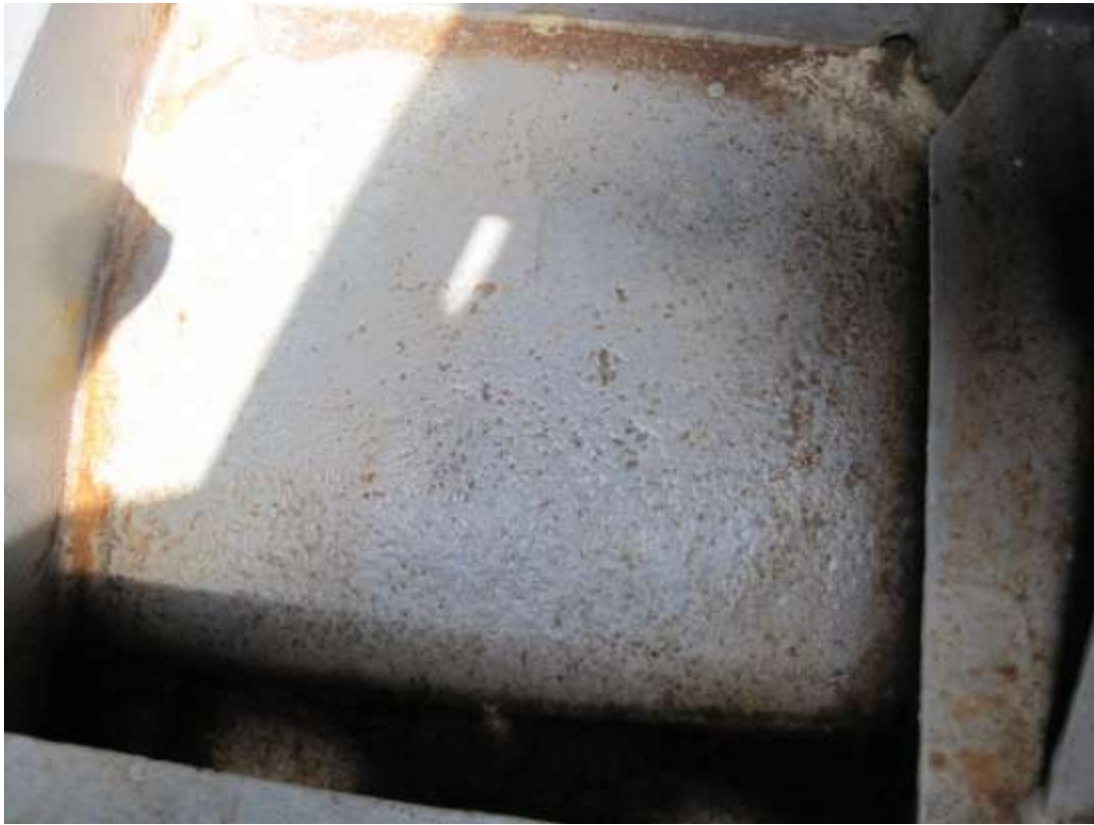
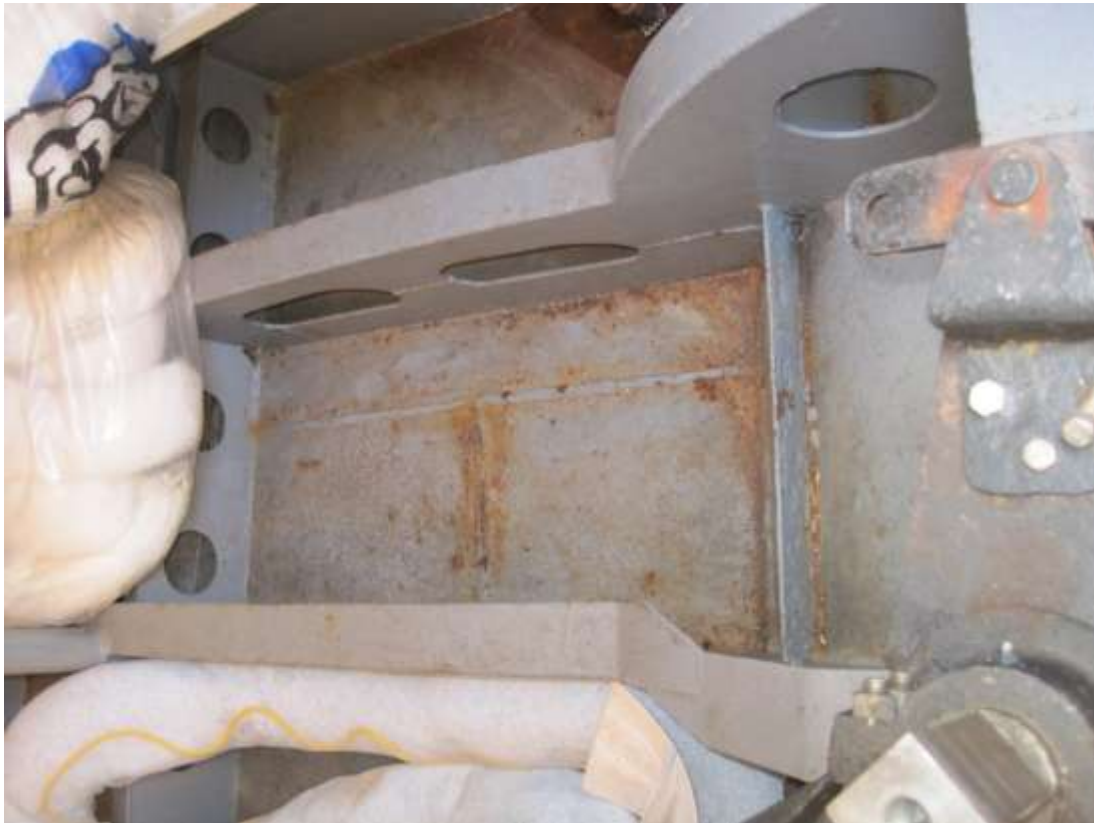
Photo Nos. 15 and 16: Pitted plating in lazarette.

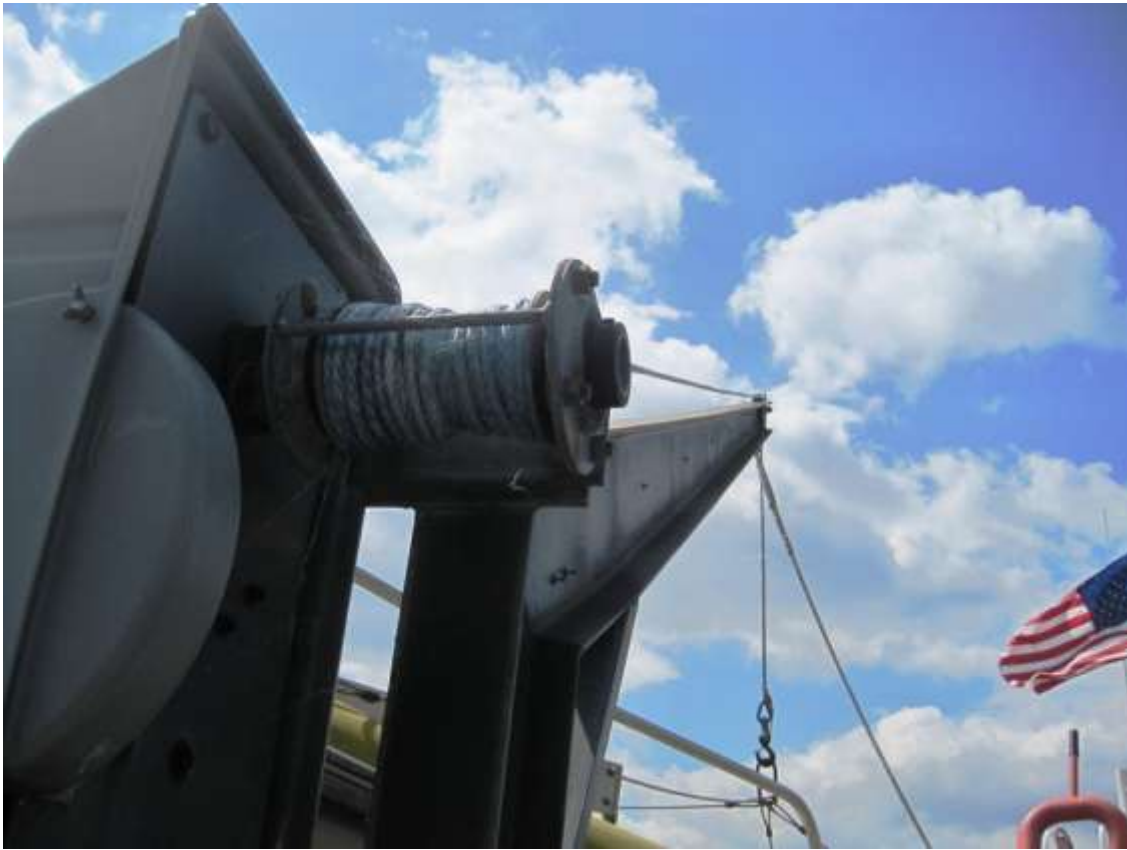
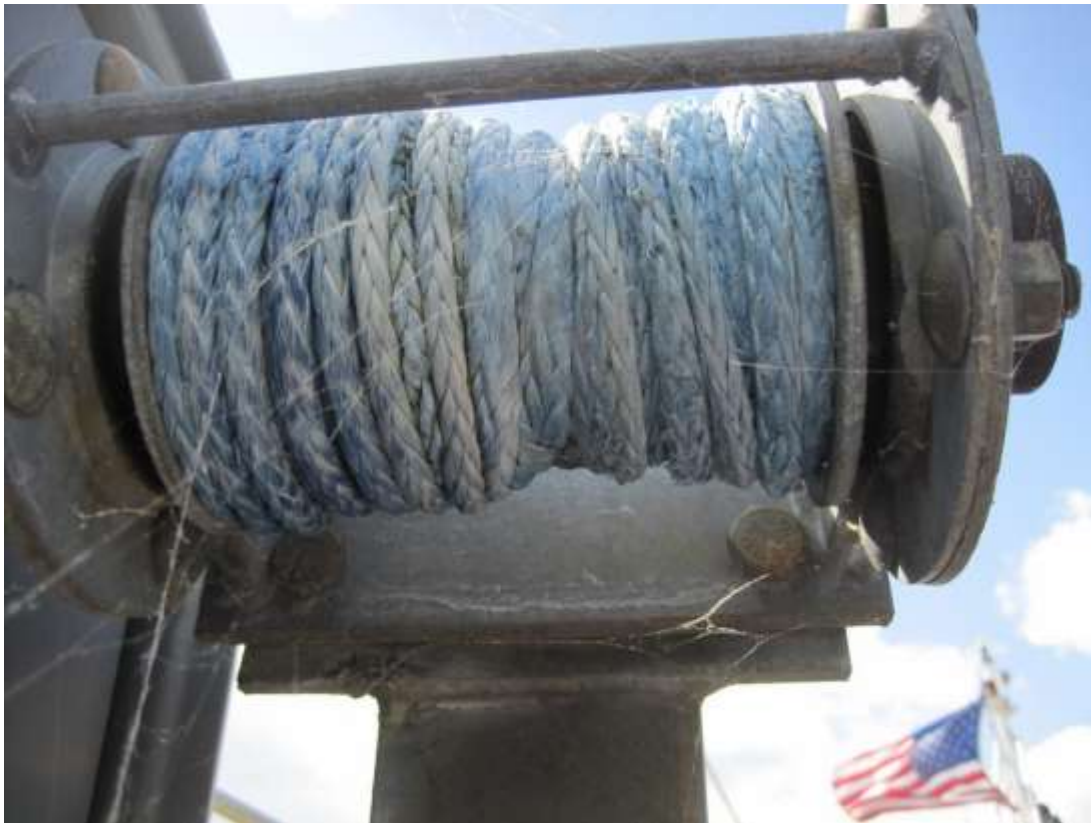
Photo Nos. 17 and 18: Faded Kevlar boat davit fall.

Shore Power cable rests on deck and vessel rail, creating a tripping hazard and possible chafing damage.	Consider installation of an overhead support for the shore power cable.
Dinghy/rescue boat davit, originally designed for wire rope, currently has a Kevlar rope fall, which is weathered/faded.	Replace boat fall with new wire rope or ultraviolet-protected Kevlar rope.
Coast Guard Documentation expired in 2011.	Consult with National Vessel Documentation Center and DC legal counsel to determine need for and procedures to re-instate documentation.

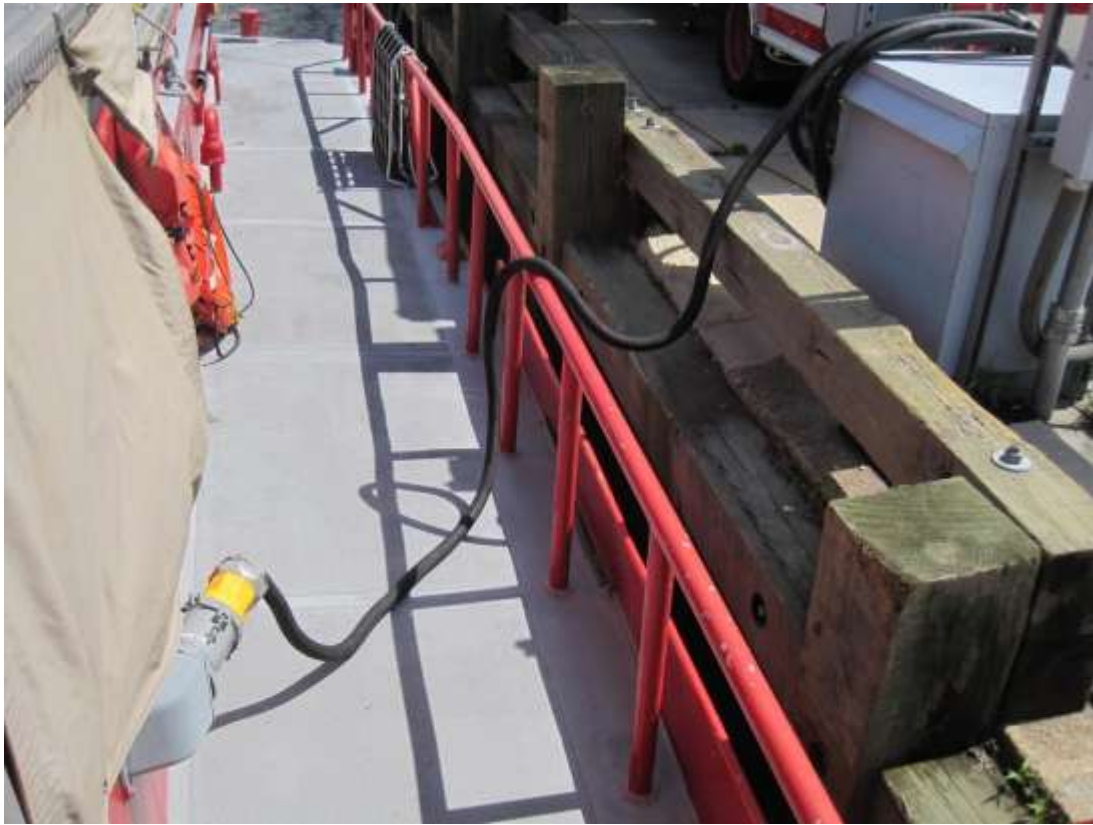
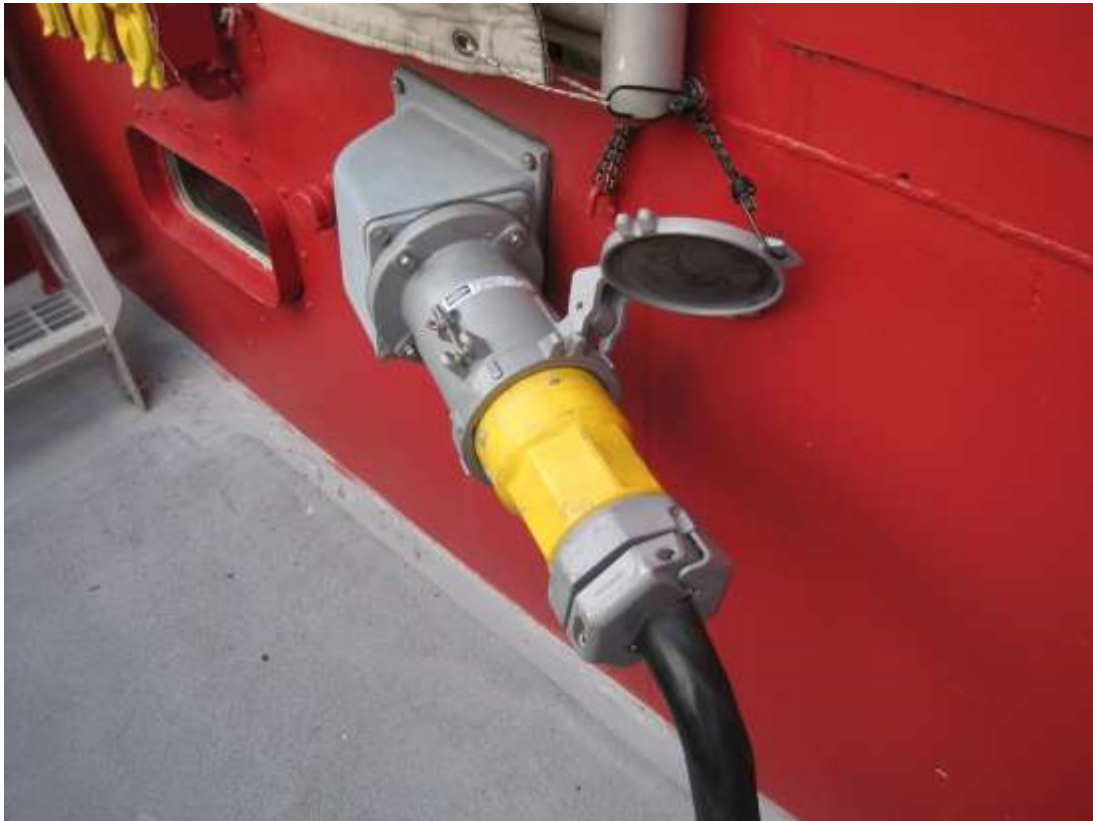
Photo Nos. 19 and 20: General views of shore power cable.

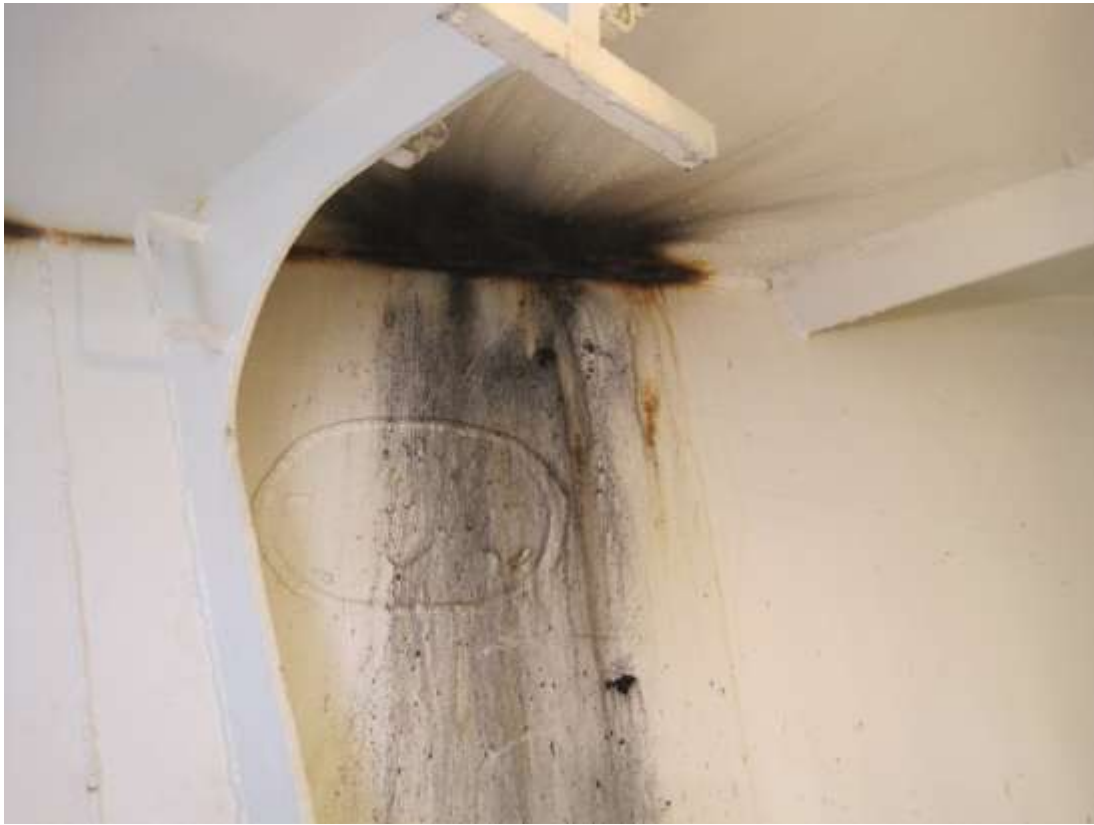
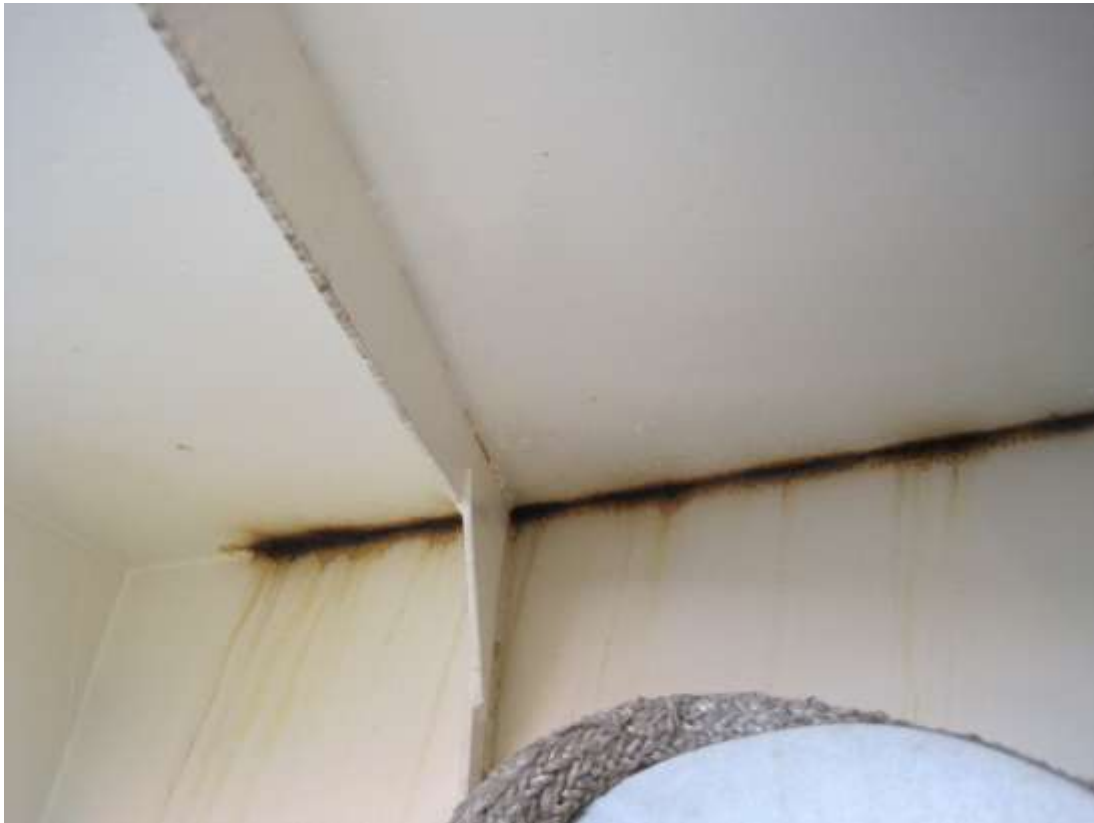
Photo Nos. 23 and 24: Recent welded crack repair in forepeak, port side.

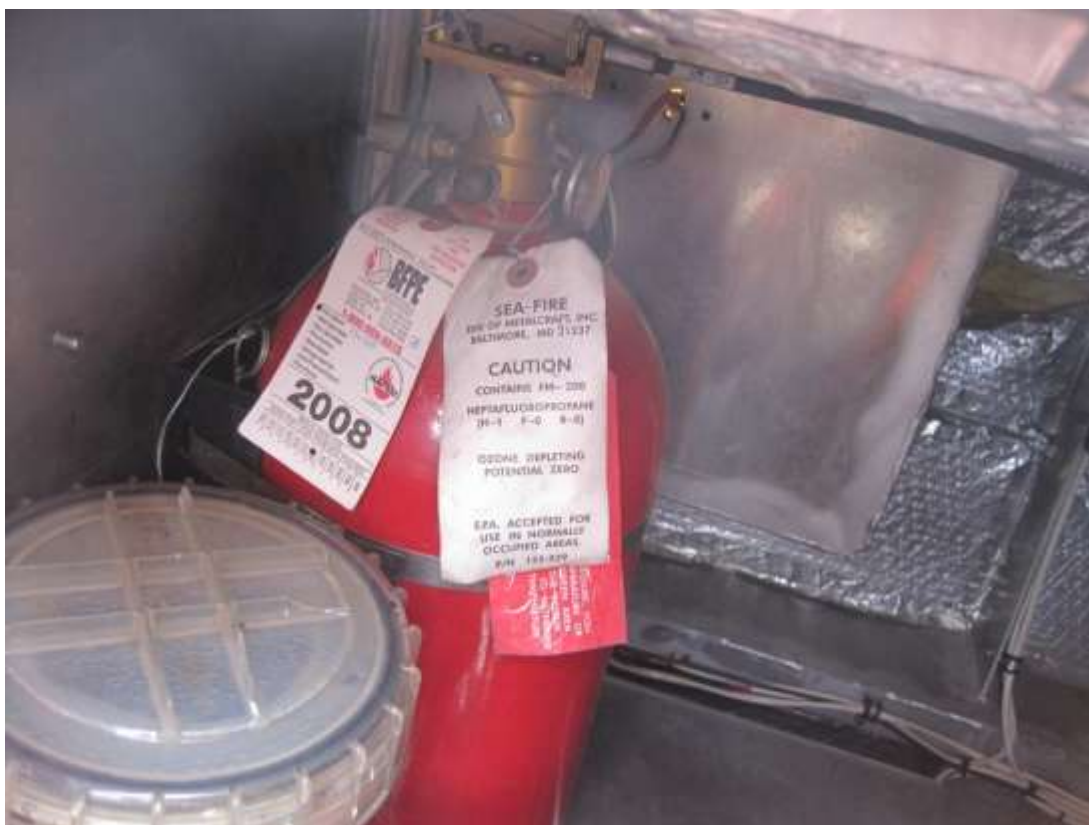
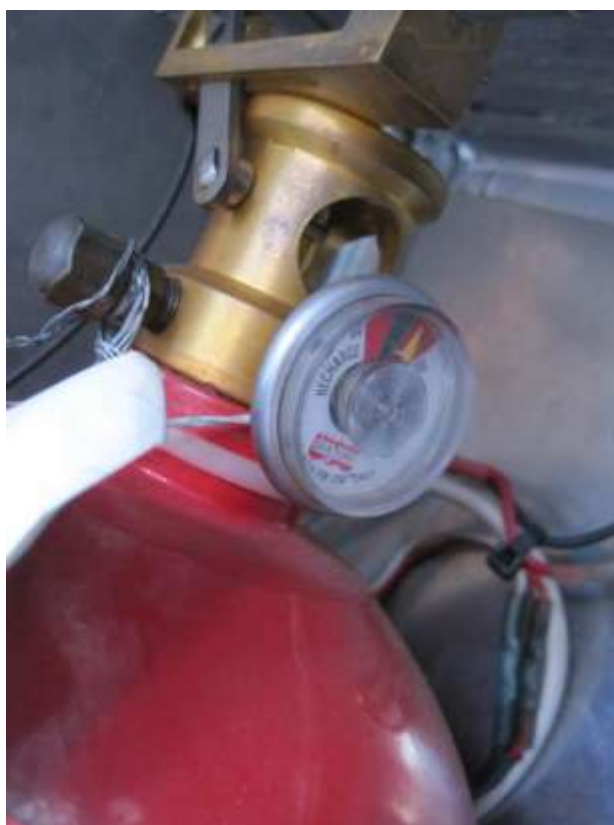
***Photo Nos. 5 and 6: Fixed fire suppression system in engine compartment.***
